UNITED STATES ENVIRONMENTAL PROTECTION AGENCY

MEMORANDUM - DRAFT

SUBJECT: Review of the Supplemental Corrective Measures Study 2017 Letter Report and Ecological Risk Evaluation for the International Paper Site in Wiggins, MS

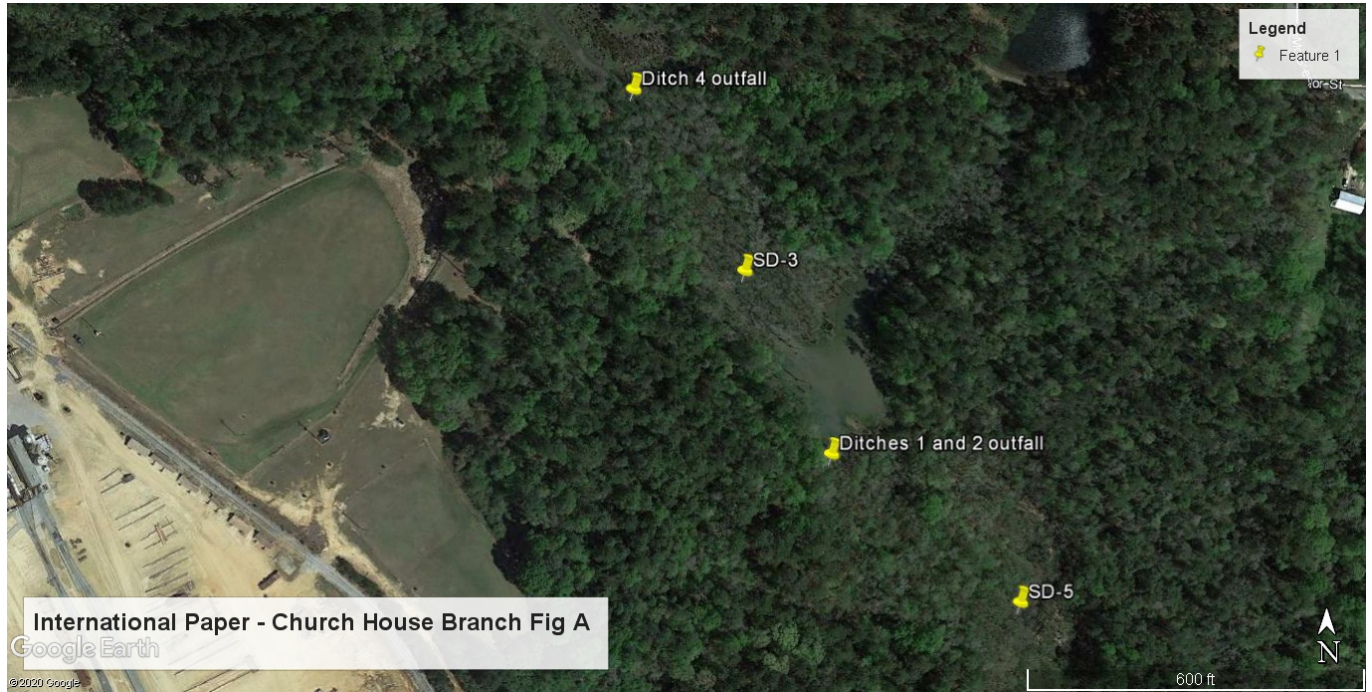
Figure A. Church House Branch sediment sampling locations and ditch outfall locations.

Elevated dioxin concentrations had been reported for sediments in Church House Branch (CHB), so further sampling of CHB sediments was requested. IP had samples taken at sample locations SD-1, SD-3, SD-5, SD-6, and SD-7. The results as TCDD-TEQs (dioxin-equivalent concentrations) for mammals are presented in Table 3 (P. 12/103) in the letter, and are listed for convenience in Table A below.

- Additional sediment sampling in Church House Branch between Ditch 4 outfall and SD-5 to better delineate the extent of dioxin/furan contamination in the sediments, in the creek and also in the ponded area
- Collection of fish and invertebrates (and plants?) from the creek/pond area between Ditch 4 outfall and SD-5 to measure the dioxin contamination in the tissues, to provide better data for use in the risk calculations
- Also potentially consider collecting information from the Ditch 4 to SD-5 stretch of the creek that could be used to assess the potential for natural attenuation/recovery regarding the dioxin contamination
